CASE STUDY:

Hammer Spring Alternation in CZ 75.

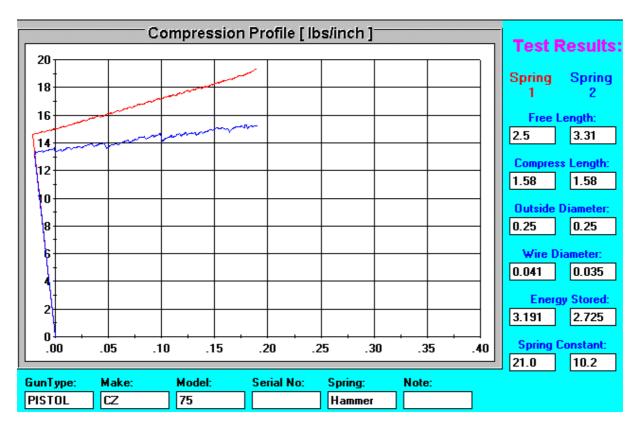
The hammer spring in this pistol operates within 1.58" (hammer fully cocked) and 1.76" (hammer fully dropped), which provides 0.18" for the spring compression. The following chart obtained with TriggerScan compares the original spring (Spring 1) with the aftermarket spring (Spring 2). The instrument examines the springs by compressing each of them from 1.76" to 1.58" in length. Then, for each spring it automatically determines the "Energy Stored" (which equals the area under the curve) and the "Spring Constant" (also called the stiffness). Note that under normal operation the traces start on the left side of the vertical axis, since the datapoints are compensated for deflection of the instrument's sensor finger under load.

Original spring: Red profile. The spring has a free length of 2.5" and O.D of 0.25". It is made of 33 coils of 0.041" steel wire. The spring exhibits fairly smooth linear characteristics. It stores 3.1 inch*lb of energy and has a stiffness of 21 lb/inch.

New spring: Blue profile. The spring has a free length of 3.3" and O.D of 0.25". It is made of 33 coils of 0.035" steel wire. The spring exhibits linear characteristics. The jerky spots are caused by the spring coils dragging on the guiding rod. The spring stores 2.7 inch*lb of energy, which is 12% less than the original, and has a stiffness of 10 Lb/inch.

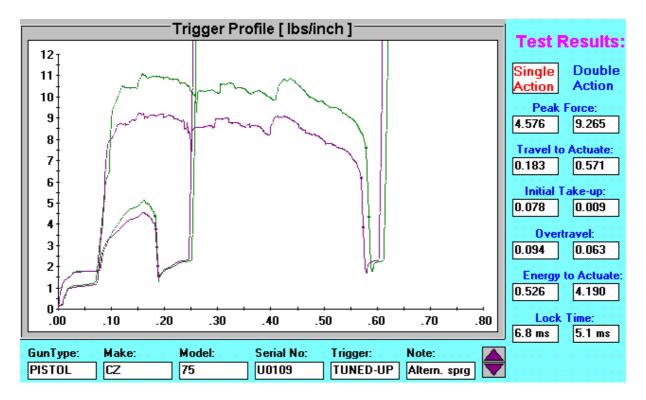
Trigger profile with the original spring: shown in green. In single action the trigger breaks at 5.2 pounds and has .182 inch of travel to fire. In double action it breaks at 11.1 pounds and has .579 of travel. In both cases, there is a moderate amount of initial take-up and overtravel. Overtravel is greater in single action mode. The energy or amount work needed to actuate the trigger, graphically represented by the area under the curve is 0.557 inch*pounds in single action and 5.045 inch*pounds in double action. This means that 10 times higher effort is needed to fire the gun in double action than in single action mode. Lock time is 5.7 milliseconds in single action and 4.4 millisecond in double action.

Trigger profile with the new spring: shown in purple. The trigger breaks at 4.6 pounds in single and 9.3 pounds at double action mode. The travel remains about the same. The energy needed in order to actuate the trigger is 0.526 inch*pounds in single action and 4.190 inch*pounds in double action. This means that almost 8 times as much effort is needed to fire the gun in double action than in single action mode. Lock time is 6.8 ms in single action and 5.1 ms in double action.

Test fire: the pistol was tested with the new spring over a period of several weeks. I liked the lighter trigger pull, which allowed more precise shooting, especially in double action pull. After a while, I had a misfire. Misfires occurred repeatedly every 50 to 100 rounds, with various kinds of ammo.

Conclusion: The aftermaket hammer spring lightened the trigger by 12% (SA) and 16% (DA). It took 6% less effort (SA) and 17 % less effort (DA) to fire the gun with the new spring. This allowed more precise shooting, but on the other hand it lowered the safety margin against an unintended shot. The lock time increased with the new spring by 19% (SA) and 16% (DA). The energy of the firing mechanism, determined from the spring profile, was about 15% lower with the new spring, which resulted into 1 to 2 misfires in every hundred rounds fired.

After this test I decided it was a good idea to reinstall the factory original hammer spring in this gun.
